INSURV SAFETY CONCERNS

LCDR Angel Salinas

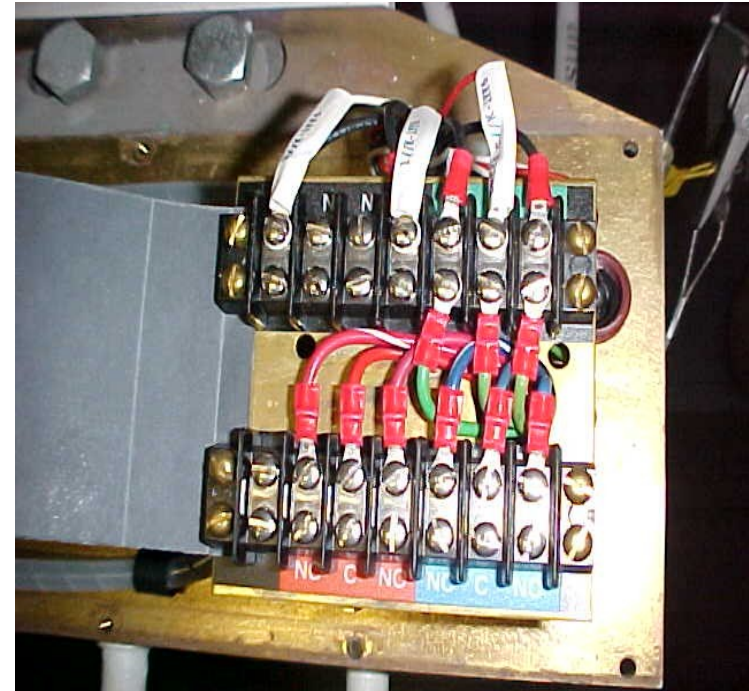
AFFF SOPV

- **AFFF SOPV are not wired for burn out protection.**
- **Wiring prints conflict (NAVSEA & MFR)**
- **Ship's Force do not have clear direction to wire SOPV correctly.**

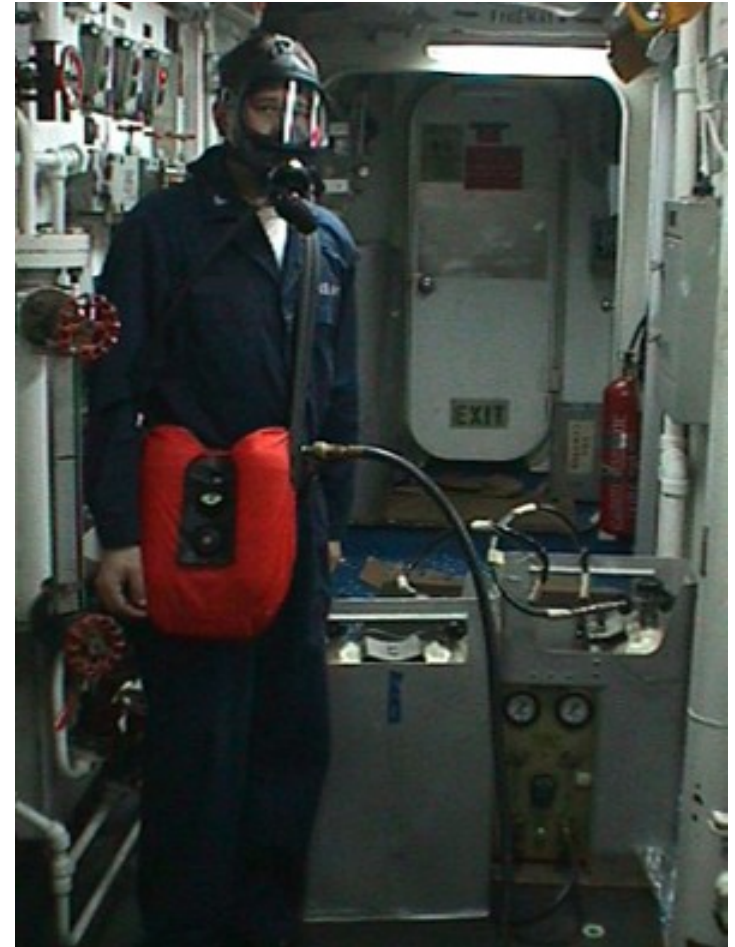
SAR/SCBA for GFE

- **SAR/SCBA equipment is not being maintained IAW PMS.**
- **Bottles are not hydrostatic tested (every 3yrs).**
- **Gages are not tested/calibrated.**
- **Bottles are low in pressure.**

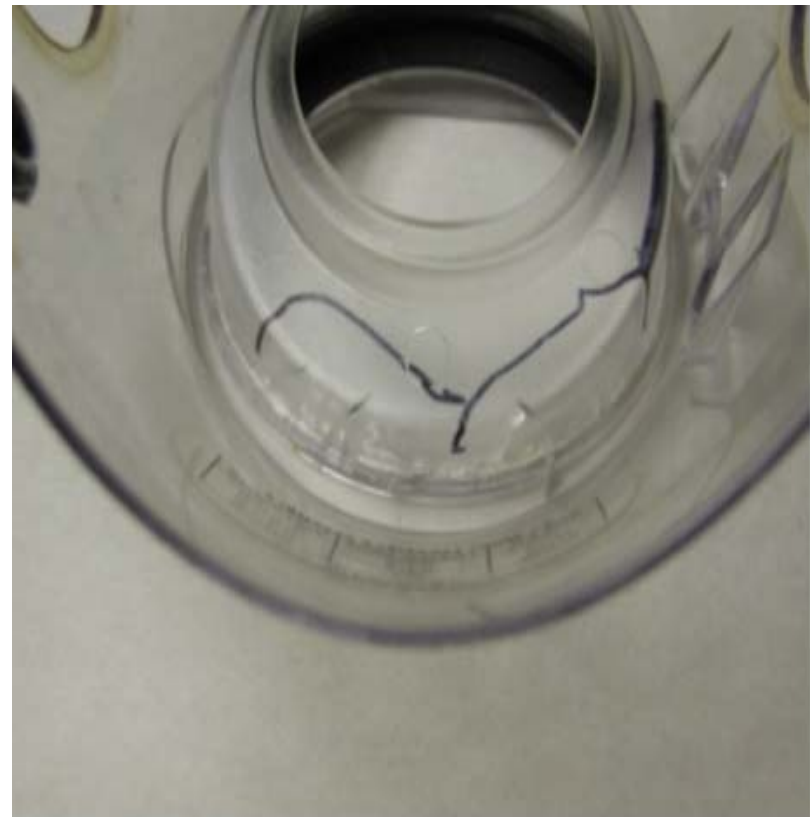
INSURV SAFETY CONCERNS **SCBA FACE PIECES**

- **SCBA face pieces are cracked.**
- **S/F is not identifying cracks in the SCBA face pieces.**

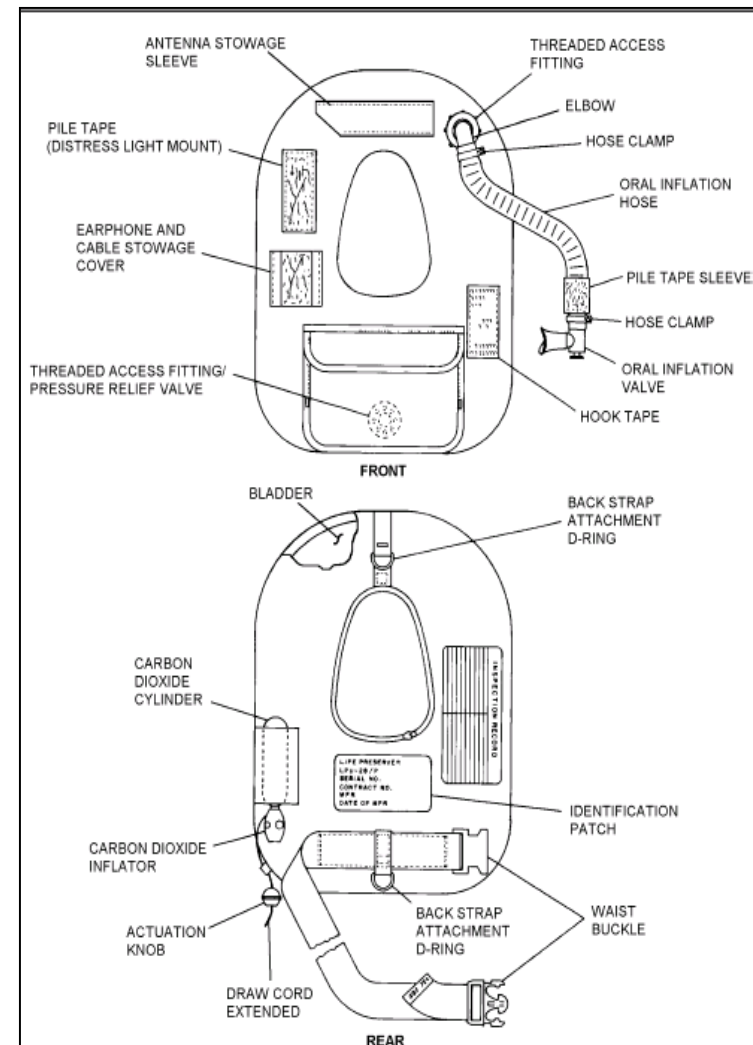
INSURV SAFETY CONCERNS LPU-28 LIFE PRESERVER (SURFACE SAR SWIMMER VEST)

- **Maintenance not being performed or recorded IAW NAVAIR 13-1-6.1-2.**

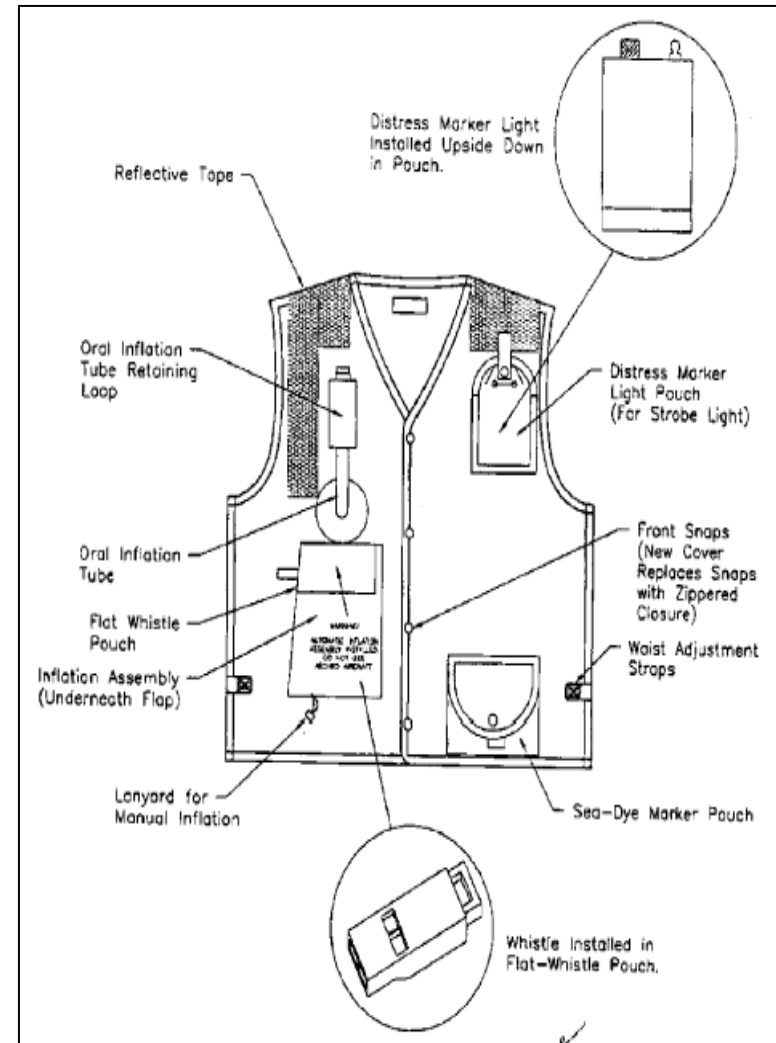
INSURV SAFETY CONCERNS MK1 LIFE PRESERVER

- **Sea Dye Markers not installed.**
- **Defective C02 cylinders installed.**

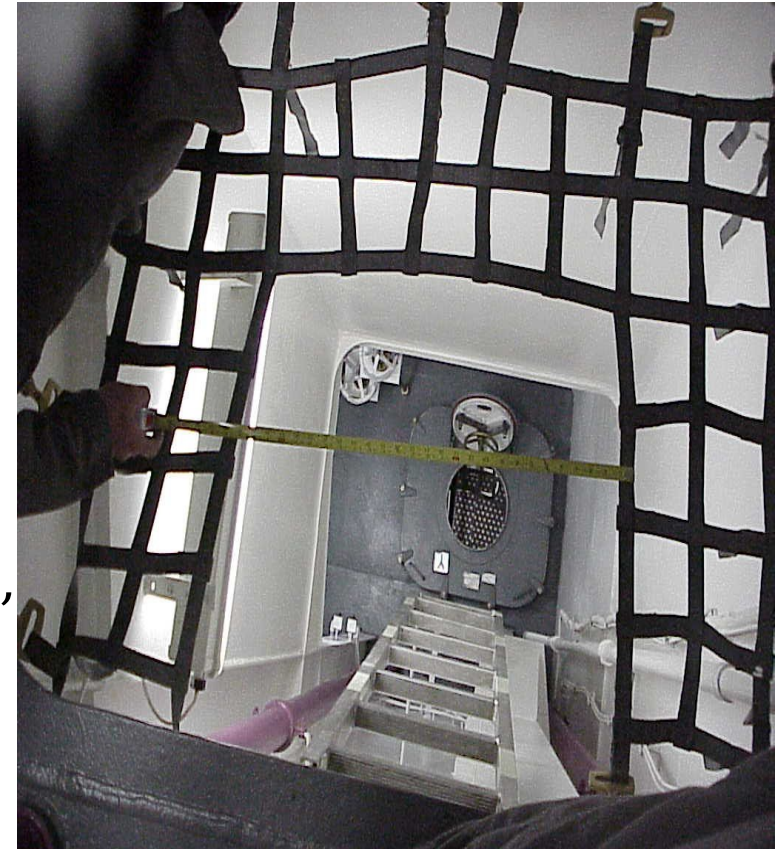
ACCESS TRUNK SAFETY NETS

- Incorrect installation/design of access trunk safety nets.

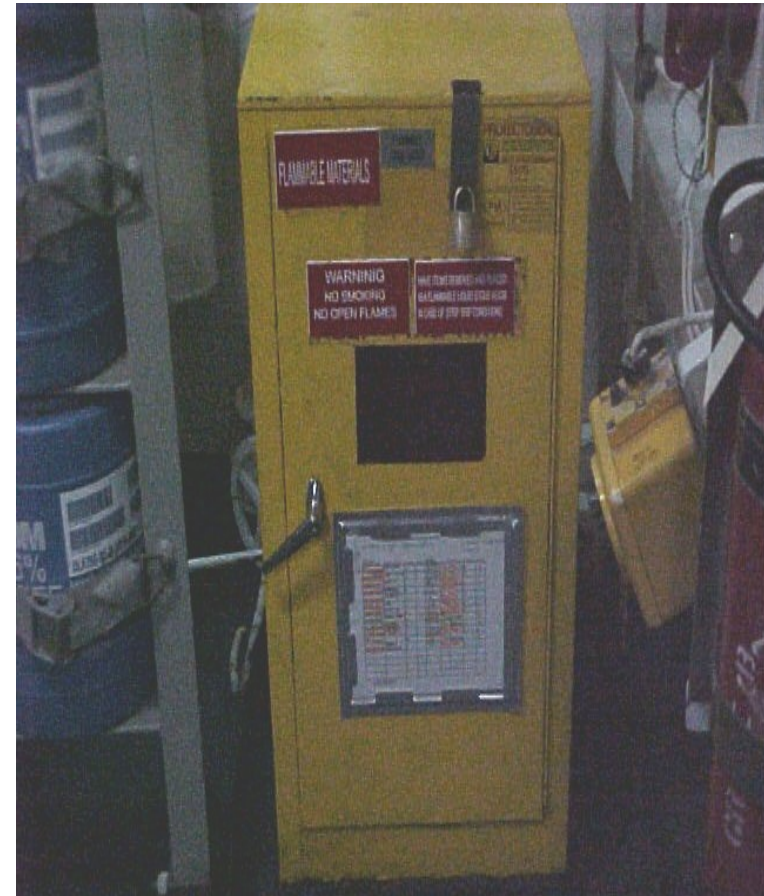
INSURV SAFETY CONCERNS IN-USE FLAMMABLE STORAGE CABINETS

- Not being maintained IAW the Q-36R Maintenance Requirement Card (MRC) 98 Y72L N from DCPO MIP 6641.

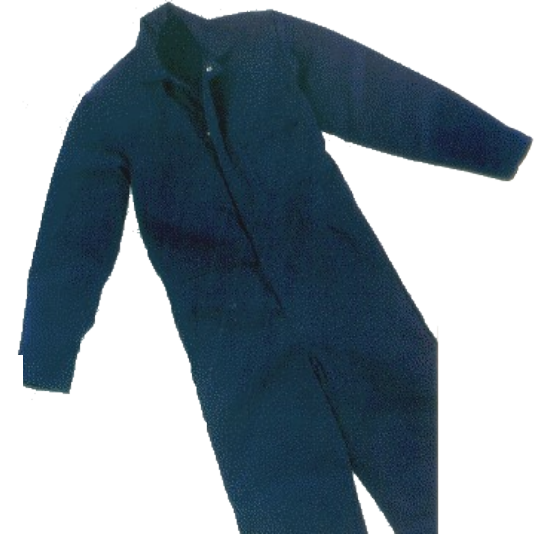
PERSONAL PROTECTIVE EQUIPMENT (PPE)

- Ships are in MINIMAL compliance in wearing fire retardant coveralls and SEEDS.
- INSURV inspection data trend shows improvement but compliance is far from 100 %

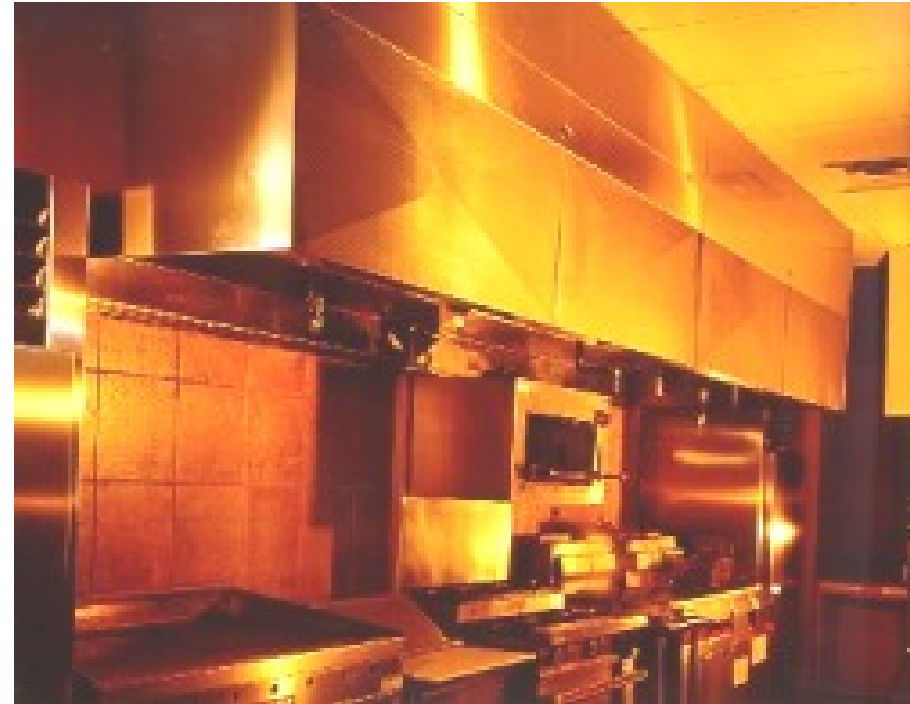
GAYLORD HOOD INTERCEPTOR SYSTEM

- Shipboard hot water heaters are not supplying hood system with the required minimum temperature of 160F.

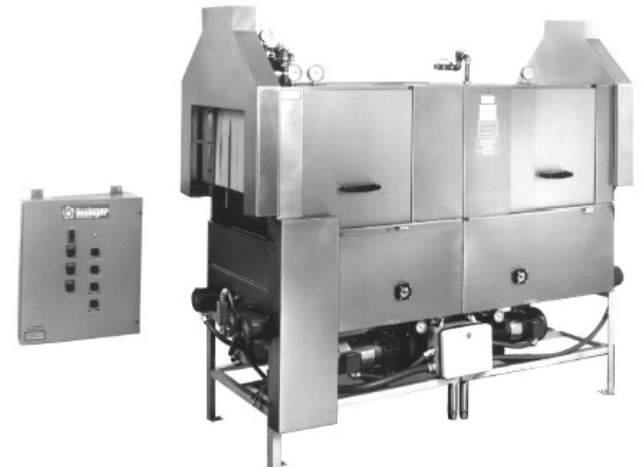
SINGLE AND MULTI-TANK DISHWASHERS

- Final rinse temps are not reaching the minimum requirement of 180 F.
- Improper sanitation & cleanliness can lead to illness of crew members at temperatures below 180 F.

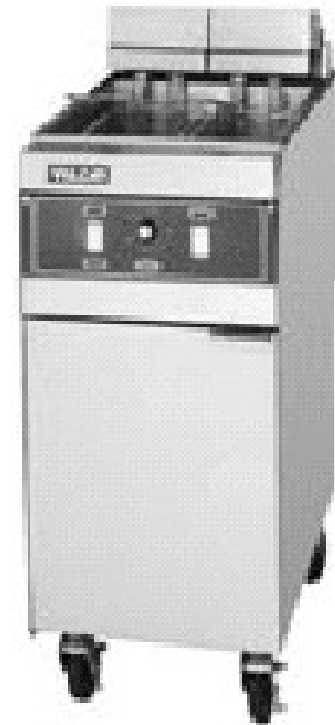
DEEP FAT FRYER

- Deep fat fryers have failed to trip at the maximum temperature of 460 F.
- Potential for personnel & property damage can occur when the grease heats to temps above 460 F.

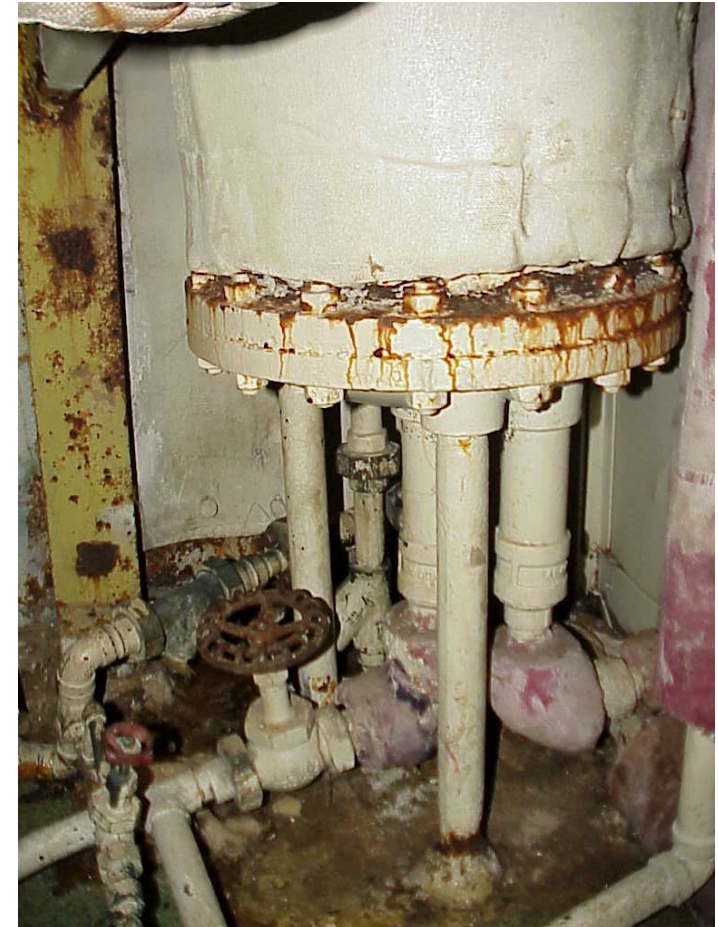
STEAM WATER HEATERS ^{USE} *for WASHROOM*

- MATERIAL CONDITION.
- OPERATING TEMPS LISTED IN PMS EXCEED THE SAFETY RANGE OF NSTM 533.
